## Unanticipated Multiple Seam Stresses From Pillar Systems Behaving As Pseudo Gob – Case Histories

**Michael Gauna**, Mining Engineer  
Technical Support  
MSHA, Pittsburgh Safety and Health Technology Center  
Triadelphia, WV

**Christopher Mark**, Principal Roof Control Specialist  
Technical Support  
MSHA, Pittsburgh Safety and Health Technology Center  
Pittsburgh, PA

## MULTIPLE SEAM PSEUDO GOB CASE STUDIES

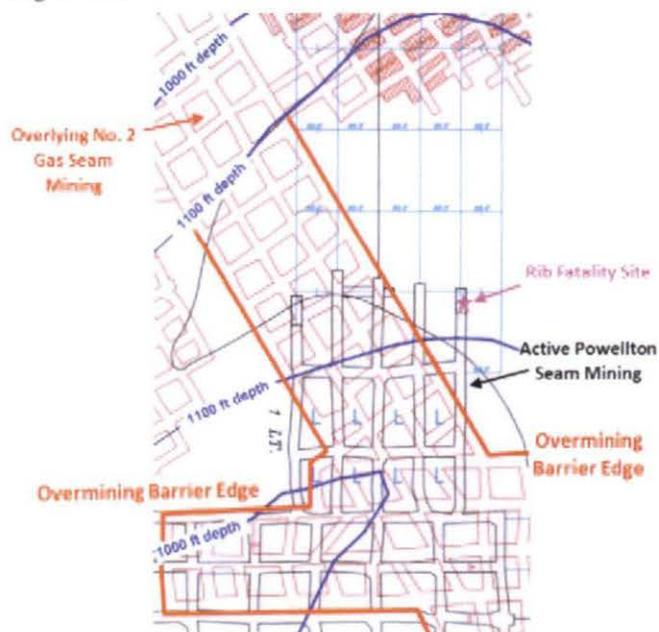
The section was overlain by development mining in the No. 2 Gas Seam with 65 feet (20 m) of interburden (Figure 2). U.S. multiple seam mining research has shown that when overlying seams have no pillar recovery and consist of development mining, this interburden distance normally will have minimal stress interaction. The investigation revealed that pillars located under the No. 2 Gas Seam chain pillars showed no or minimal evidence of rib spall (Figure 3). In contrast, ribs located beneath the edge of the overlying barrier pillar exhibited intense rib sloughing (Figure 4). The accident occurred in the Powellton Seam # 5 entry face area after it had advanced beneath the overlying barrier. The accident site was subjected to an elevated intensity of rib sloughing and the rib side had a thick shale parting that had a tendency to roll out as large blocks.

Figure 2. Powellton Seam mining completed (black) with overlying development mining in the No. 2 Gas Seam (red).

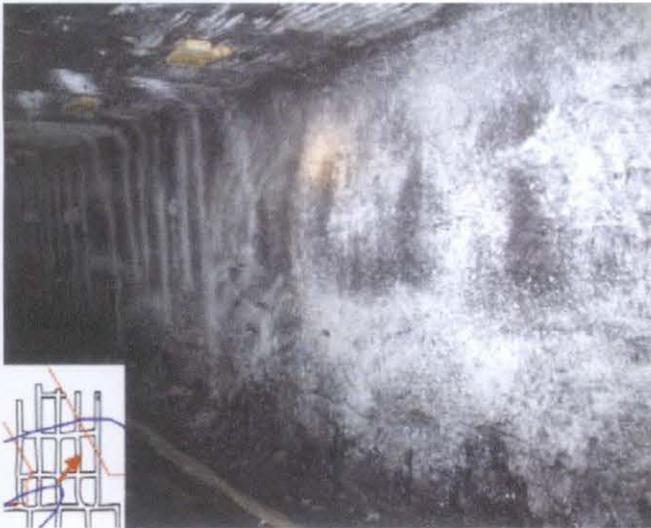
**Figure 3. Powellton Seam mining under the No. 2 Gas Seam chain pillars showing no evidence of rib spall; photo view shown by arrow on embedded map.**

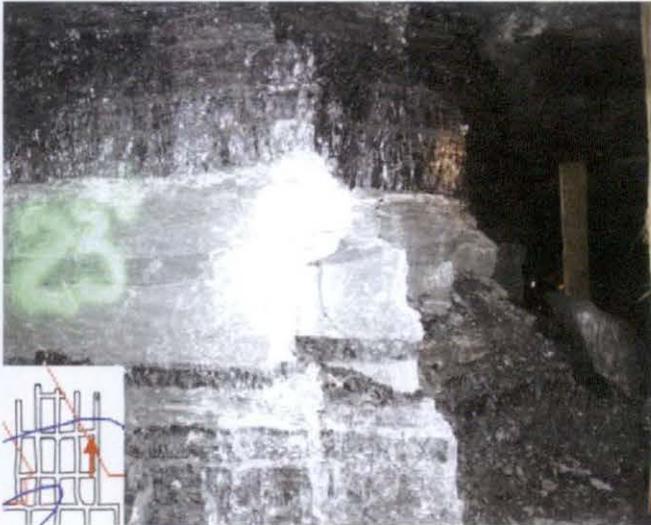
**Figure 4. Powellton Seam mining within the overlying barrier pillar exhibiting intense rib sloughing; photo view shown by arrow on embedded map. Photo illustrates thick shale parting that tends to roll out as large blocks.**

Powellton Seam mining shows that if the No. 2 Gas Seam chain pillars are treated as gob, pillar SF = 2; however, a “condition yellow” cautionary warning is generated indicating the likelihood of rib instability.

Rib control measures were subsequently instituted in the high stress region. In-cycle rib bolting was instituted to protect the personnel. Also, the mine operator purchased “inside control” dual boom bolting machines, with drill station controls located between the drill booms, so that roof bolt machine operators could work in a zone where they were protected from the rib hazard.

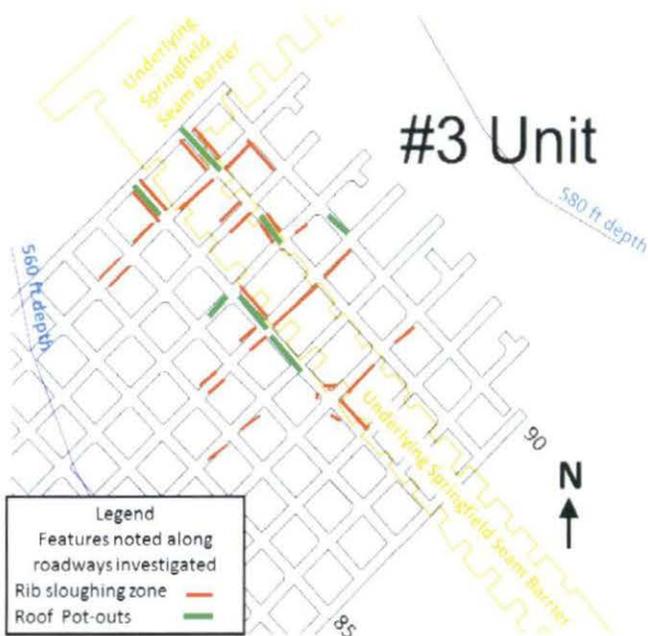
An example of the Baker Seam mining encountering underlying remnant structure at 570-foot (174 m) depth is shown in Figure 5. In the example, mining is on 80 x 80-foot (24 x 24 m) centers with crosscut center increased to 120-foot (37 m) over an underlying remnant barrier in the Springfield Seam. As noted on Figure 5, roof pot-outs tend to flank the perimeter of the barrier and were consistent with roof flexure from the subsidence troughs that flanked the underlying barrier (Phillipson and Muto, 2015).

Figure 5. Baker Seam mining (black) on 80 x 80-foot (24 x 24 m) centers with crosscut center increased to 120-foot (37 m) over underlying remnant barrier (tan) in the Springfield Seam. Rib sloughing and roof pot-outs plotted from an intermittent traverse where all roadways are not mapped (Phillipson and Muto, 2015).

The roof support system did not require modification. However, pillar rib sloughing was severe and persistent directly above and in the vicinity of the underlying barrier to the extent that rib support was installed to control further deterioration using wire mesh panels secured with 4-foot (1.2 m) fully grouted bolts and 6 x 16-inch (15 x 41 cm) plates (Figure 6). The investigation involved other portions of the mine and revealed that there is also a depth dependency to rib deterioration where there is an absence of multiple seam structure. As a consequence a two phase rib support program was established (Phillipson and Muto, 2015):

- Entries or crosscuts that cross a Springfield Seam barrier at any depth, or lies within 50 feet (15 m) of its vertical projection, have rib support installed in the upper coal bench.
- At depths greater than 500 feet (152 m), all critical entries (defined as escapeways, intake entry, belt entry, supply/travel entry, and 1 return entry per mining unit) as well as crosscuts that host equipment caches and power centers where workers congregate, have rib support installed in the upper coal bench.

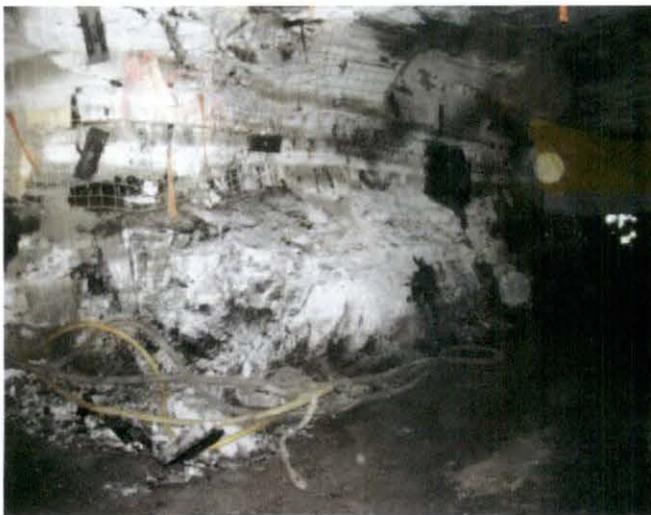
Figure 6. Typical Baker Seam rib conditions in the vicinity of an underlying barrier requiring welded wire mesh and rib bolting in the upper bench - mudstone layer of the seam (Phillipson and Muto, 2015).

The investigation led to the operation applying AMSS to insure that the Baker Seam pillars that cross the underlying multiple seam structures have adequate pillar stability to achieve global stability. An assessment of the AMSS procedures by MSHA-TS led to establishing a site specific Baker Seam AMSS evaluation for this mine's multiple seam environments. In the example shown in Figure 5, the 80 x 80-foot (24 x 24 m) center pillar system had crosscuts extended over the barrier to 120-foot (37 m) center and establishes an acceptable AMSS derived stability factor. However, the AMSS warning remains that stress interaction will be significant to where robust roof and rib support will likely be required to have local stability. The conditions noted in the underground investigation validate the need for robust ground support even with increased pillar stability which is a common situation in multiple seam mining scenarios.

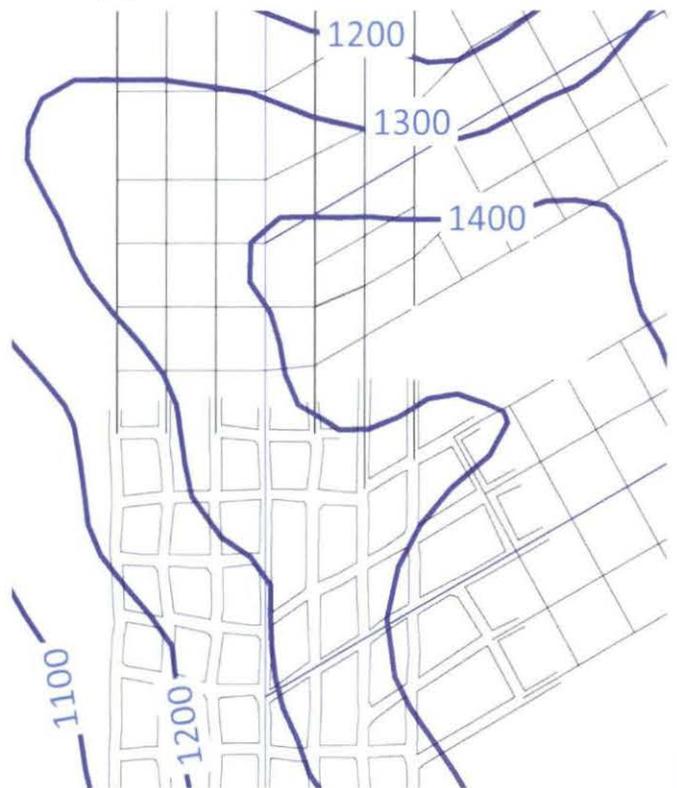
Figure 7. Kellioka Seam six entry submain being developed to establish pillar recovery panels at 1200 to 1400-foot (370 to 430 m) depth of cover.

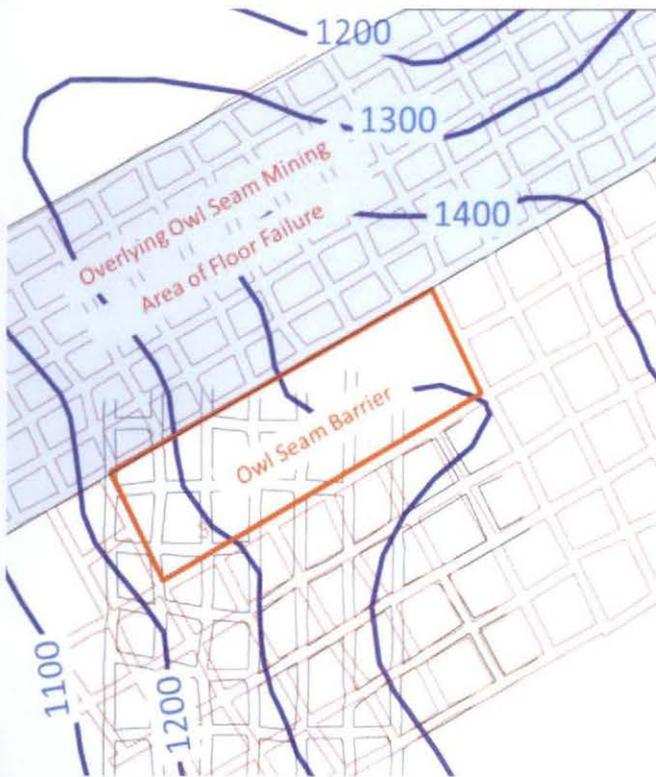
**Figure 8.** Kellioka Seam six entry submain (black) overlain by Owl Seam pillars and barrier (red) showing Owl Seam panel having reported floor failure (shaded).

The ARMPS SF calculated for the overlying Owl Seam pillars was 2.5, which would normally indicate a stable pillar configuration. However, floor failure was noted, and later adjoining mining employed larger pillars for Owl Seam development (Figure 8). An AMSS evaluation of the Kellioka Seam mining assuming the Owl Seam failed panel as gob, indicates

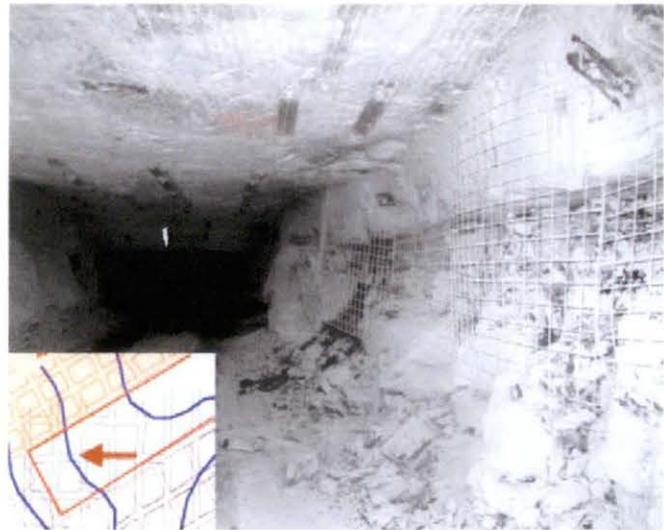
**Figure 9.** Kellioka Seam pillar showing rib sloughing from multiple seam stress interaction (view shown by arrow on embedded map).

a stable pillar system ( $SF = 1.58$ ); however, a cautionary warning exists indicating the possibility of interaction affecting roof and rib stability which did occur as noted in the investigation.

The need to install roof-to-floor support to cope with roof deterioration stopped the section advance (Figure 9). To avoid the problem area, the mine elected to advance the development elsewhere. Kellioka Seam entries were superimposed under Owl Seam entries and mining under the intact Owl Seam barriers was avoided. Mining then advanced into the distressed zone under the overlying panel, and then tied back into the stopped entries to establish ventilation using reduced mining widths and robust roof support.

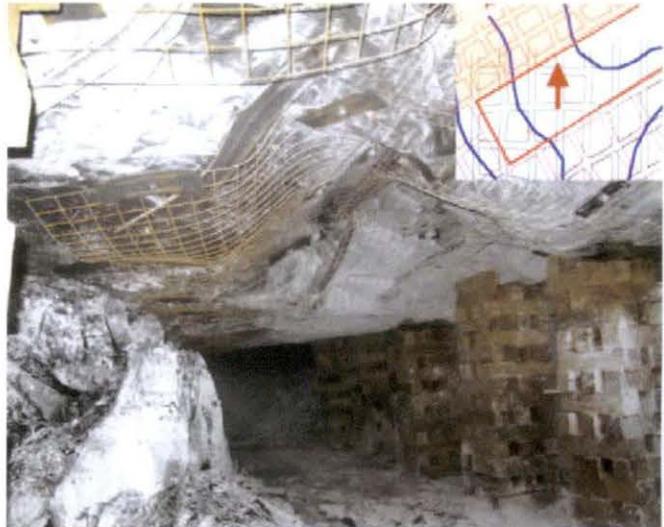
**Figure 10.** Kellioka Seam roof geologic structure, small drag fold, degradation and pillar rib sloughing from multiple seam stress interaction.

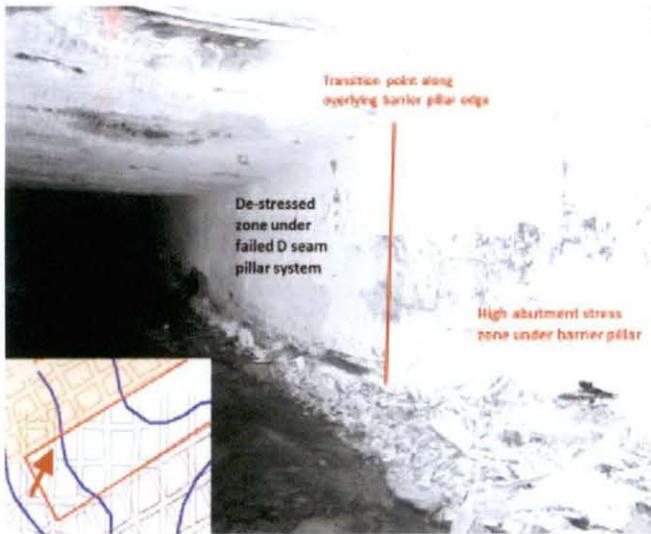
However, multiple seam stress interaction became apparent from overlying Owl Seam workings. The Kellioka Seam submain is also in a transition zone where the development advanced under an Owl Seam barrier that adjoins a seven entry panel having 72 x 95-foot (22 x 29 m) center pillars (Figure 8). The Owl seam panel was reported to have experienced floor failure, which would have shifted considerable load to the adjacent barrier pillar. The investigation revealed that the Kellioka Seam mining under the Owl Seam barrier exhibited elevated stress that generated rib spall and roof degradation (Figures 9 and 10). In contrast, the mining under the failed Owl Seam pillar system offered a de-stressed region with a clear definition of where the de-stressed zone is and the position of the overlying edge of the barrier (Figure 11).

**Figure 11.** Kellioka Seam mining having de-stressed conditions under the he failed Owl Seam pillar system and also showing a definite location of the overlying edge of the Owl Seam barrier.

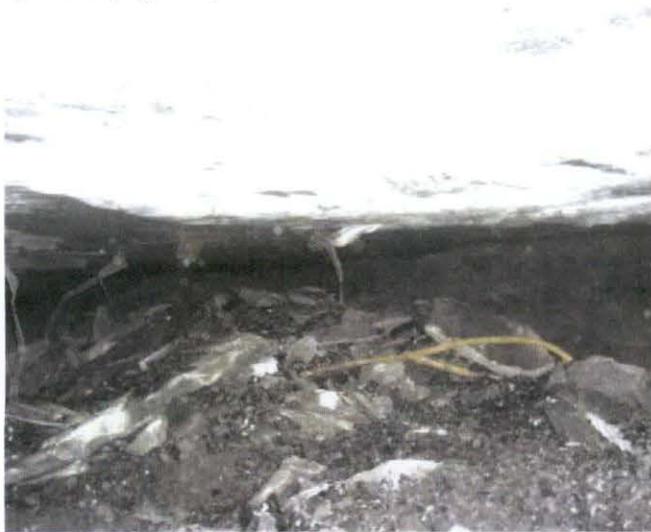
**Figure 12.** Coal pillar and immediate roof material filling entry after the 2001 Kellioka Seam burst event.

After the 2001 event, no further mining was allowed in areas where the depth exceeded 1500 feet (460 m) and where underlying barriers were present. The subsequent burst in 2002, which occurred at a traditional gob-solid crossing at 1400-foot (425 m) depth of cover, led to further mining restrictions for depths greater than 1000-foot (300 m).

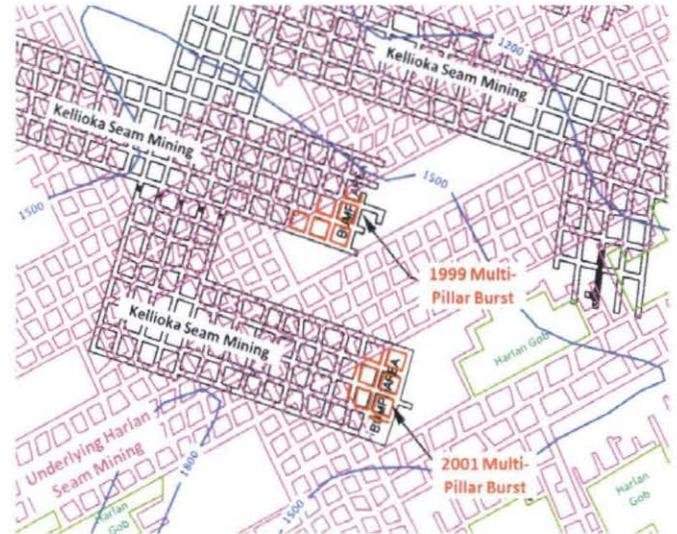
**Figure 13.** Kellioka Seam burst events with affected pillars identified in MSHA – TS investigations outlined in red. Depth of cover and underlying Harlan Seam workings (magenta) shown. Kellioka Seam bursts are surrounding mining at the time of 2001 event.

at the time of the events inferred that the Harlan Seam barriers underlying the Kellioka Seam bursts were highly stressed. It appears that yield in the Harlan Seam pillar systems created a pseudo gob that transferred stress onto the adjacent barriers. When coupled with the depth of cover and Kellioka Seam burst prone geologic conditions, the events occurred when the Kellioka Seam development advanced over the underlying barriers.

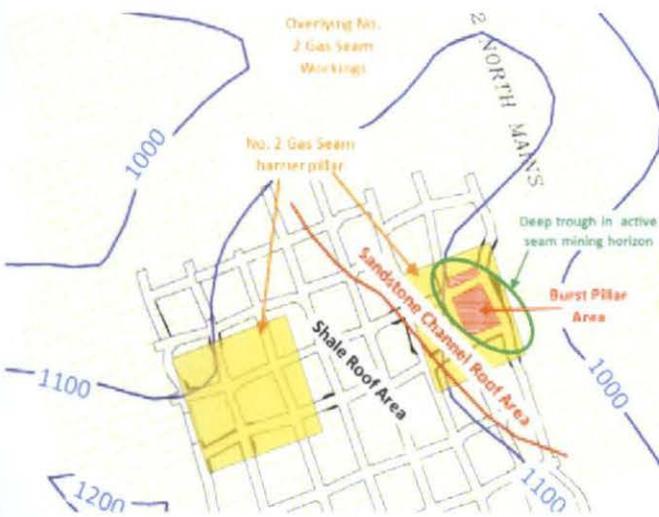
Figure 14. Powellton Seam mains (black) showing burst pillar area (red hatch) with depth of cover and overlying No. 2 Gas Seam workings (orange); larger overlying remnant barriers identified by orange shading.

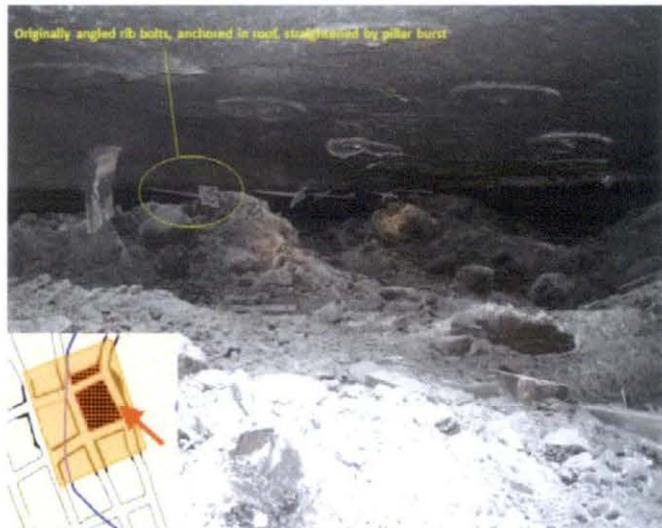
The Powellton Seam burst region (Figure 15) and degraded shale roof (Figure 16) were both situated approximately 60 feet (18 m) beneath large pillars, 240 x 225-foot and 190 x 225-foot (73 x 69 m and 58 x 69 m), that had been left in the overlying No. 2 Gas Seam. The No. 2 Gas Seam large pillars are surrounded by much smaller pillars, measuring 40 x 50-foot (12 x 15 m). The apparent lack of loading observed on the Powellton Seam pillar ribs located beneath the overlying small pillars indicated that the small pillars were acting as pseudo gob, transferring load to the large pillars which acted as remnant barriers.

Figure 15. Pillar burst material filling No. 8 entry.

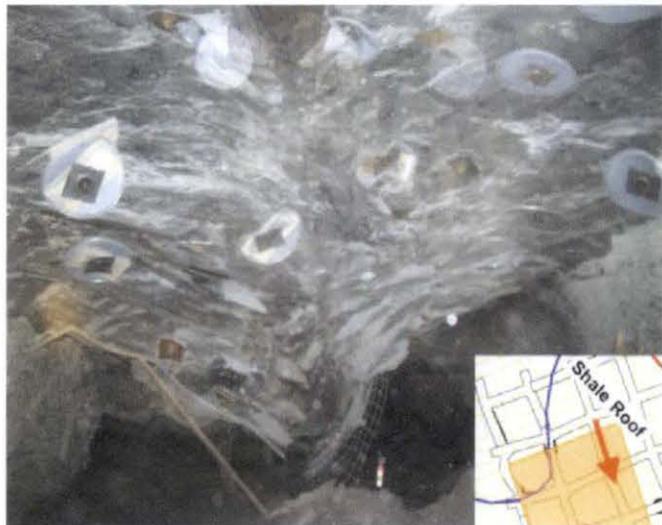
Figure 16. Failed shale roof under No. 2 Gas Seam remnant barrier where roof is being squeezed downward by pressure from Powellton Seam pillar and immediate roof dilation.
