Large Scale Ground Instability Caused By Failure of Underlying Pillars: a Case Study of Dynamic Multiple Seam Interaction

ABSTRACT

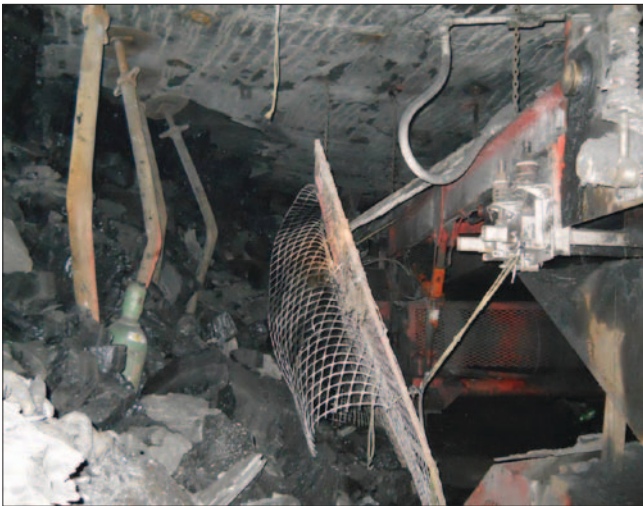
Figure 4. Floor heaving and rib roll has completely covered a belt drive located above the Dorothy barrier pillar.

Subsequent mapping (Figure 3) indicated that the worst conditions in the Mains were located directly over the Dorothy Seam barrier pillar, from approximately crosscut 24 in the small pillar area to crosscut 2 in the large pillar area (see the photos in Figures 4 and 5). The area from crosscut 18 to 24 was also severely damaged, with long radial tension cracks in the mine roof that ran parallel with the center of the entry. These cracks had intermittent crossing cracks, which further weakened the roof. The fact that no falls occurred in these areas was a testimony to the strength of the sandstone roof. There were also intermittent areas of slight bottom heaving. Virtually every rib had shed large pieces of broken coal and rock. Further damage was noted to crosscut 14 in the north and crosscut 4 in the south.

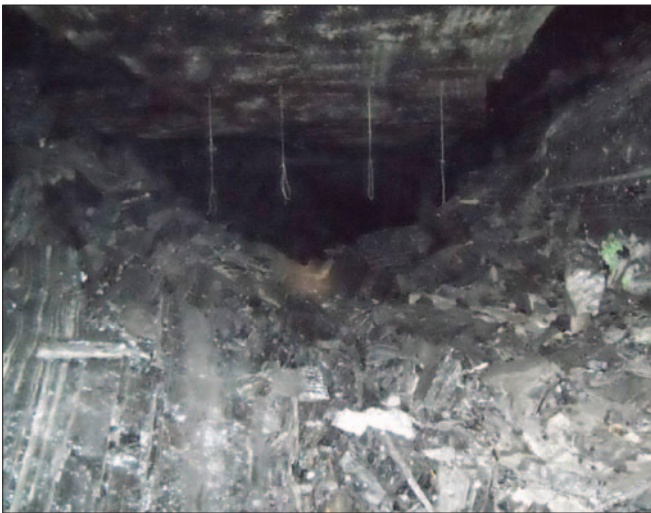
Figure 5. Coalburg entry above the Dorothy barrier pillar almost filled with broken coal, leaving only a 14-ft-wide by 6-ft-high triangular opening.
