13th CONFERENCE ON GROUND CONTROL IN MINING

The Massive Collapse of Coal Pillars - Case Histories from the United States

Frank E. Chase, *Geologist*

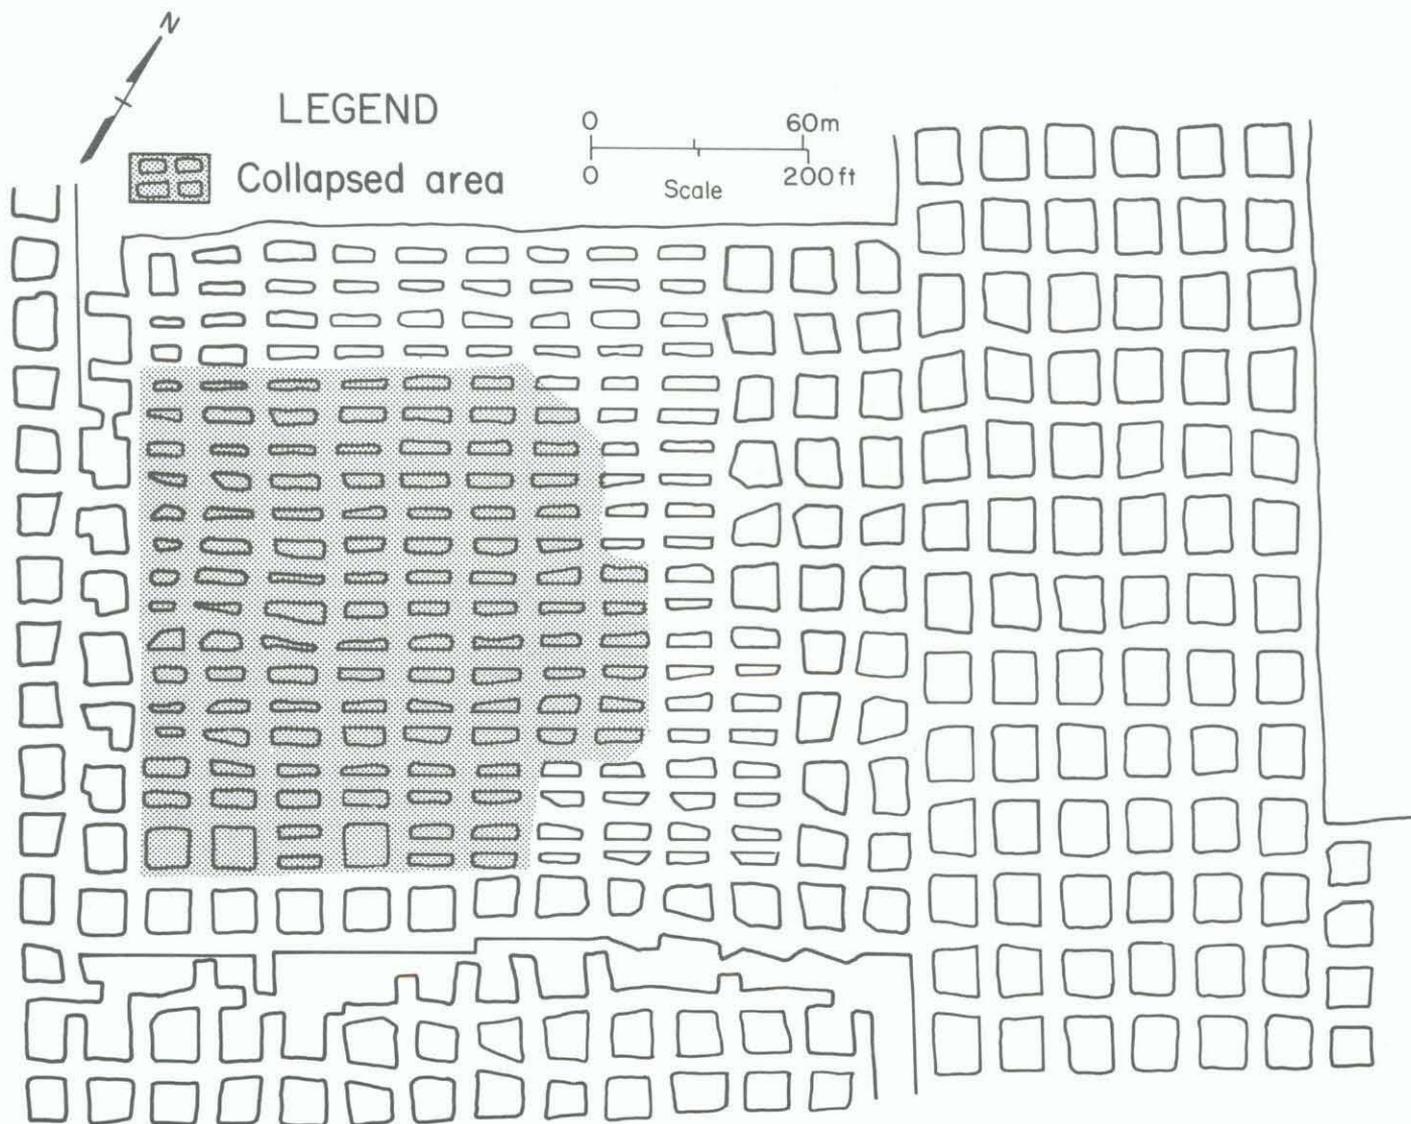
Figure 1. Failed fender workings in Mine A.

In 1991, the panel shown in figure 1 was developed. All roadways were driven on 18 m (60 ft) centers and were under 84 m (275 ft) of cover. After the panel was completed, partial pillar recovery was begun. A 6 m (20 ft) wide split was mined through the middle of each pillar, and two 3 x 12 m (10 x 40 ft) fenders with an ARMPS SF=0.75 remained. Because of the competency of the roof and the support provided by the regular spaced uniform fenders, no caving occurred while the panel was being retreat mined.

Three weeks after the panel had been abandoned, an area approximately 138 x 154 m (450 x 500 ft) containing 107 fenders collapsed (figure 1). Miners on a nearby section were knocked to the floor by the resultant airblast. One miner sustained a head injury. Fortunately, no miners were near the collapse. However, had the failure occurred 15 minutes later, two miners would have been rock dusting ribs immediately outby the area which collapsed. The airblast destroyed 26 cinder block stoppings (figure 2) and the fan house weak wall, closing the mine for days. As was the case in some of the other collapses to be discussed, not all the under sized fenders in the panel failed. Two possible explanations are put forth to explain this behavior. First, the collapse might terminate as soon as the competent roof units are again able to bridge a given span. Or, the collapse may terminate where the under sized fenders are still of sufficient size and strength to support the now cantilevering immediate roof. For example, it is conceivable that the sufficiently

Using a boundary-element-method (BEM) program similar to the USBM's MULSIM/NL program, it is possible to simulate sudden, massive pillar collapses and stable, progressive pillar failures. The collapse at Mine A, shown in figure 1, was used in these analyses to illustrate the mine stability theory. Since data on the postfailure modulus of the pillars (K_p) and the local mine modulus (K_{LMS}) is unknown, these analyses use assumed values, again, in order to illustrate the essential mechanics of massive pillar failures. For the stable case, the properties of the 3 m (9.5 ft) coal fenders with a w/h ratio of 1.05 were assumed to be an initial elastic modulus of 2,800 MPa (400,000 psi), a compressive strength of 11 MPa (1,600 psi), a residual strength after failure of 2.5 MPa (360 psi), and a postfailure modulus, K_p , of -833 MPa (-120,000 psi). This magnitude of K_p is high as suggested by the data in figure 9. The assumed compressive strength value for the pillars is slightly higher than the average stress of 9.4 MPa (1,360 psi) on the remaining fenders predicted by the tributary area theory. No field data is available to justify the assumed value for residual pillar strength after failure, although, experience suggests that this assumption is reasonable. The assumed rock mass modulus is 12,500 MPa, which means that the K_{LMS} approaches -12,500 MPa (-1,800,000 psi). Therefore, as shown in figure 10, this case satisfies the mine stability criterion since K_{LMS} is less than K_p . The BEM model should produce a stable failure.

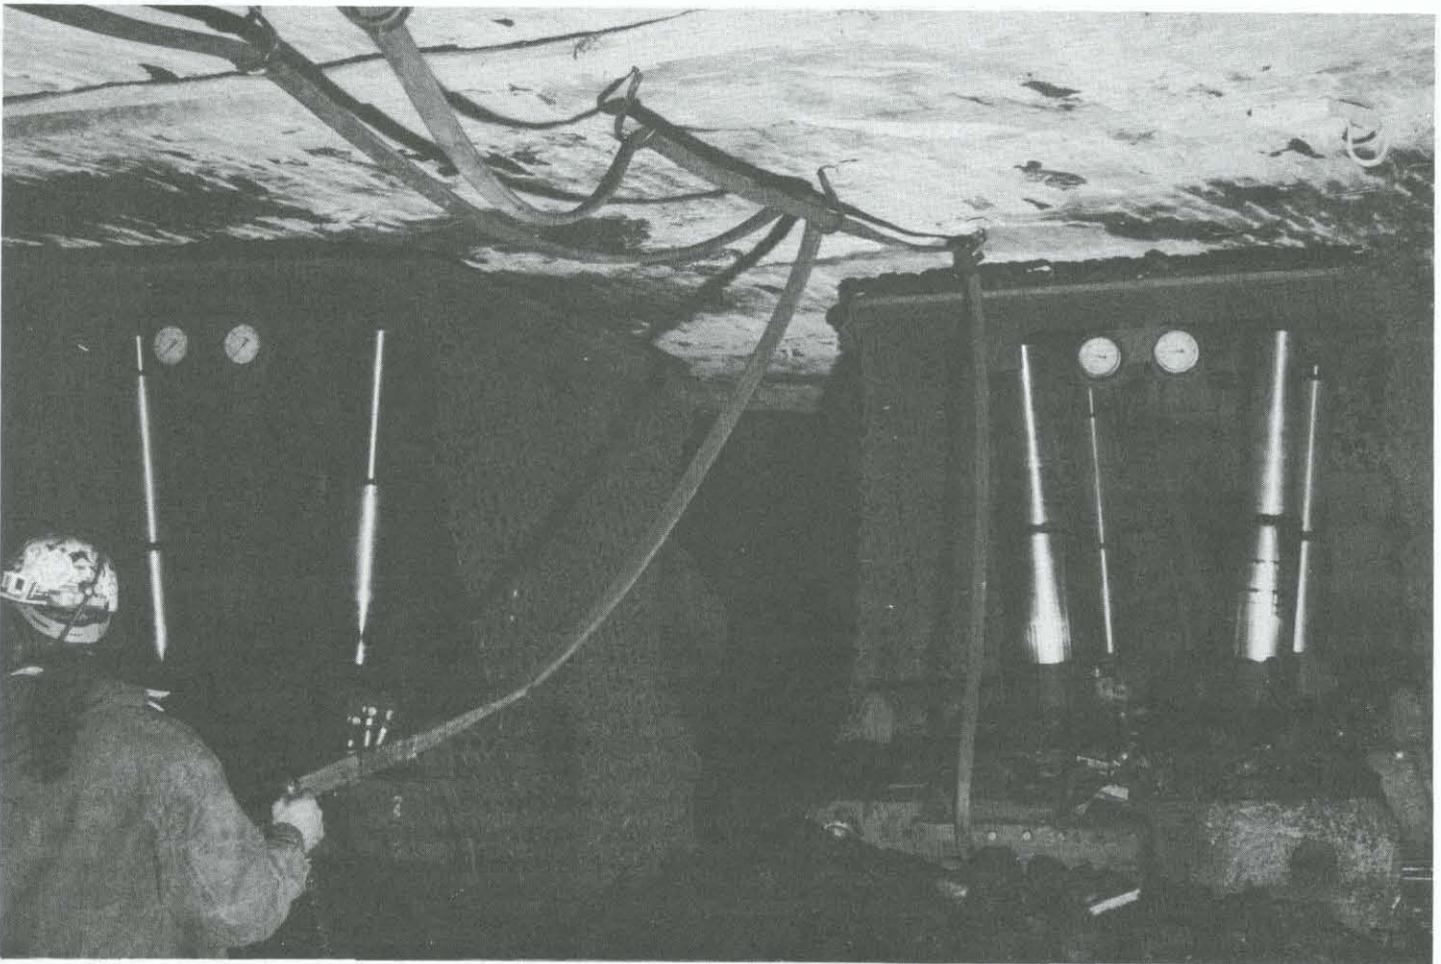
Figure 3. Full pillar extraction using mobile roof supports.

contained in the fenders. Scenarios similar to that indicated in Mine A have prompted other operators to go to full pillar extraction with the aid of mobile roof supports (figure 3). These units have repeatedly proven themselves to be a viable cost effective solution to setting turn posts in high coal conditions.

Information collected at mines which have experienced air blasts, suggests that different strategies may be successful in preventing massive pillar failures under competent roof conditions. If partial pillar extraction must be conducted, increasing the extraction percentage and/or leaving less stable remnant pillars in the gob, as was the case with diagonal pillar splitting and the Virginia 3 Cut methods, might allow the roof to cave. If traditional pillar splitting is practiced and the roof will not cave, the amount of coal extracted can be limited with the intention of designing for long-term panel stability. This might be accomplished either by increasing the size of the remnant pillars, or by leaving rows of unsplit pillars as barriers between smaller areas of split pillars. Another strategy which has worked is to go to full pillar extraction. By removing the support provided by the remnant fenders left during traditional pillar splitting, the bridging capacity of the roof should be substantially reduced. If the roof does not break during full pillar extraction, caving can be induced through explosives as documented by Unrug (1991). Concerns on production time lost in high coal conditions setting turn posts into lifts can be alleviated by the employment of mobile roof supports.

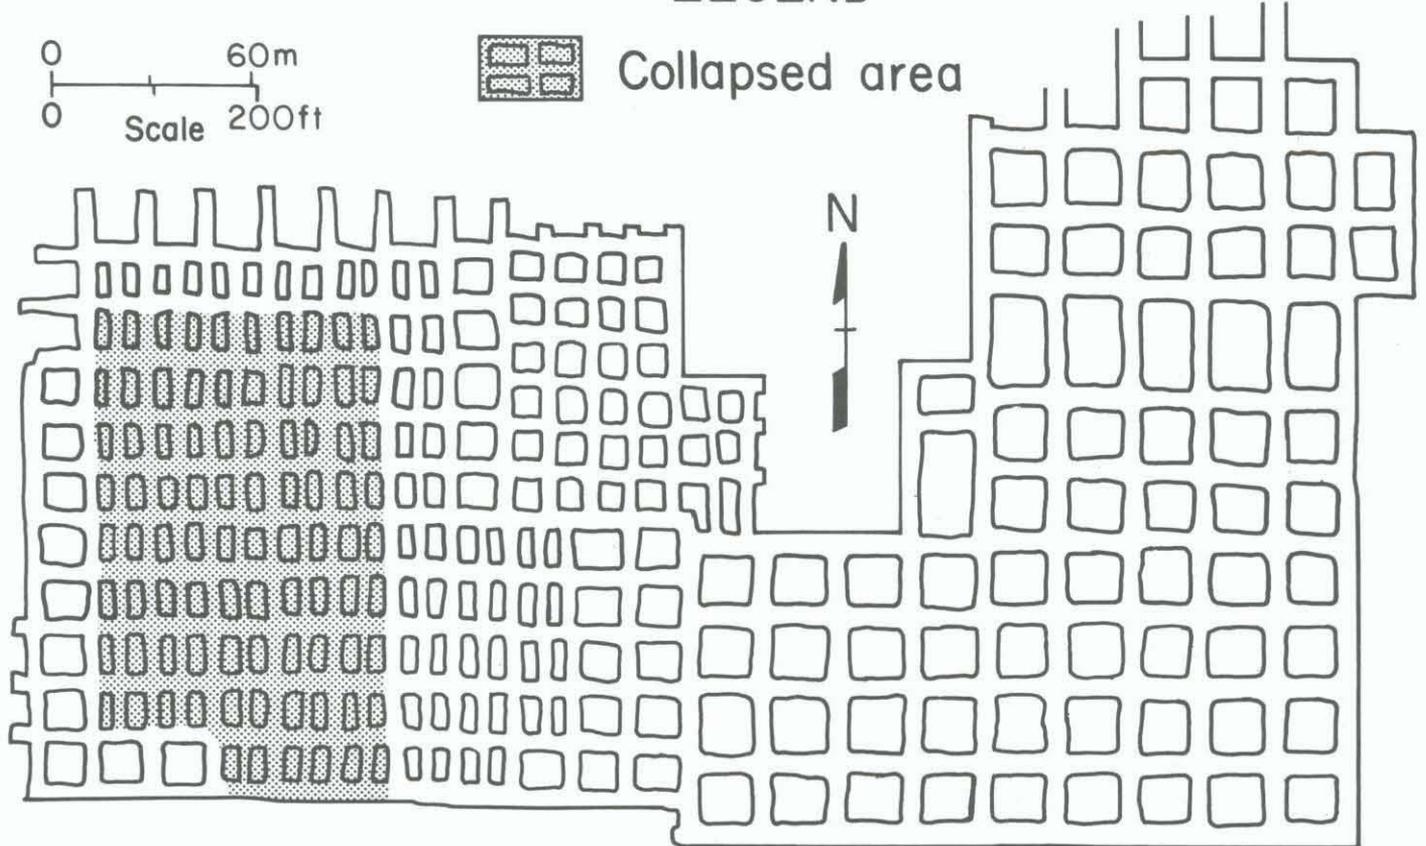
Figure 4. Location of the second pillar collapse at Mine B.

The second collapse occurred later that same year. Eighty six 3 x 12 m (10 x 40 ft) fenders with a SF=0.82 failed (figure 4). The airblast blew out 40 stoppings. Pillars measuring 12 x 12 m (40 x 40 ft) with a SF=2.45 assisted in halting the collapse. There was 75 m (245 ft) of cover over the workings.

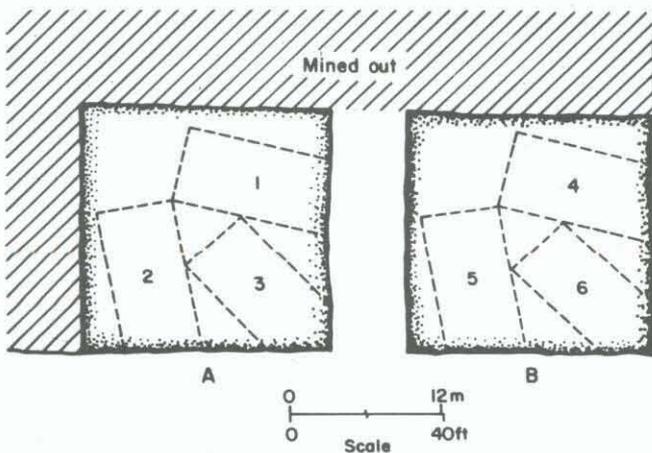
Figure 5. Virginia 3 Cut pillar extraction method.

The partial pillar recovery plan at Mine B was changed after the third airblast. Pillar measuring 20 x 20 m (65 x 65 ft) were extracted using the "Virginia 3 cut method" as shown in figure 5. In the collapsed areas where 12 x 12 m (40 x 40 ft) pillars were split, the extraction percentage was 78% as opposed to 74% using the 3 cut method. However, the 3 cut method leaves non-uniformly spaced stumps that have an irregular geometry in the gob. According to the

mine operator, these stumps routinely yielded and crushed out. Since the 3 cut method has been used in Mine B, no airblasts have been recorded.

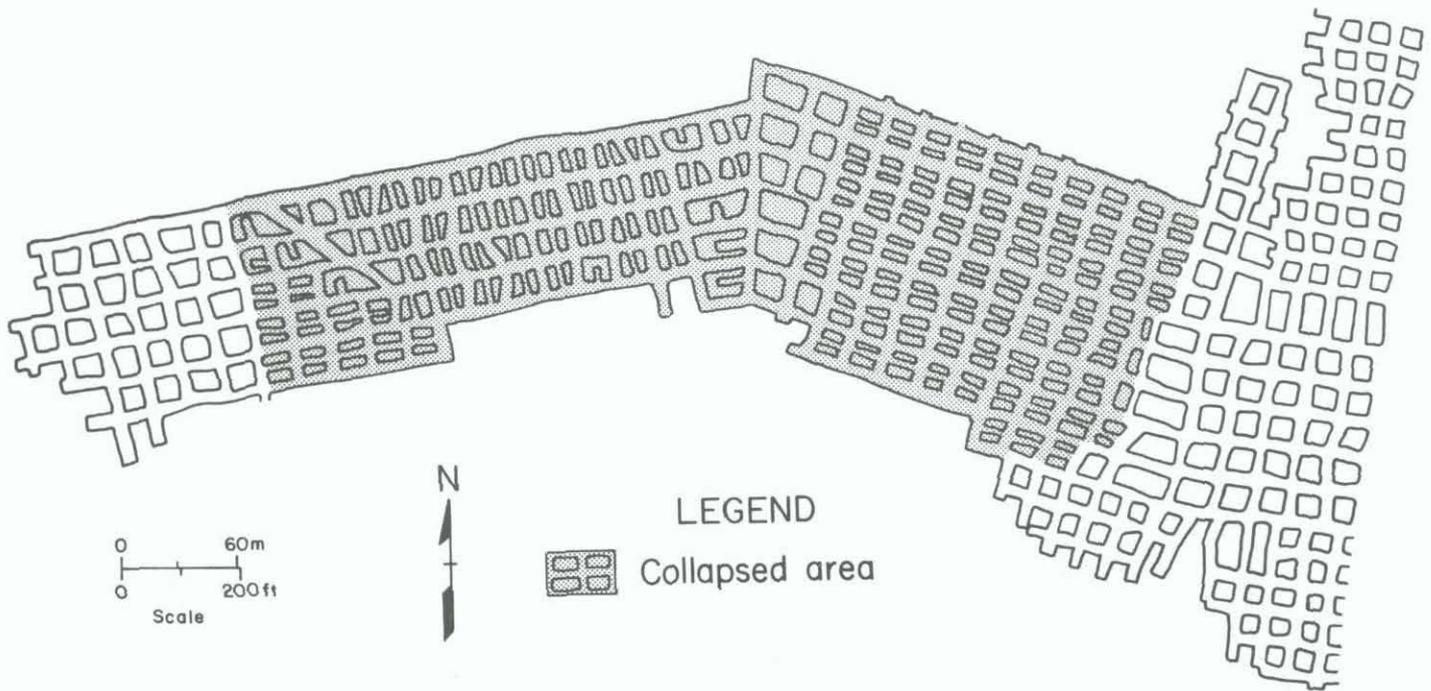
Figure 6. Location of the first pillar collapse at Mine C.

In 1992, the operator was splitting pillars in the panel shown in figure 6. After the 6 m (20 ft) wide split, two 3 x 12 m (10 x 40 ft) fenders with a SF=0.94 to 1.15 remained. When the operator began to mine the pillar row outby the last row shown split, a massive collapse of the fenders in the gobbed out area initiated. The roof bolter operator on the section indicated that he and his coworkers were knocked to the floor by the resulting airblast and 103 stoppings were destroyed. Because the area was inaccessible, it could not be determined if the unsplit pillars located approximately at mid-panel (figure 6) had failed. The pillars where the collapse terminated had a SF=2.05. Overburden in the collapsed area ranged from 53-66 m (175-215 ft).

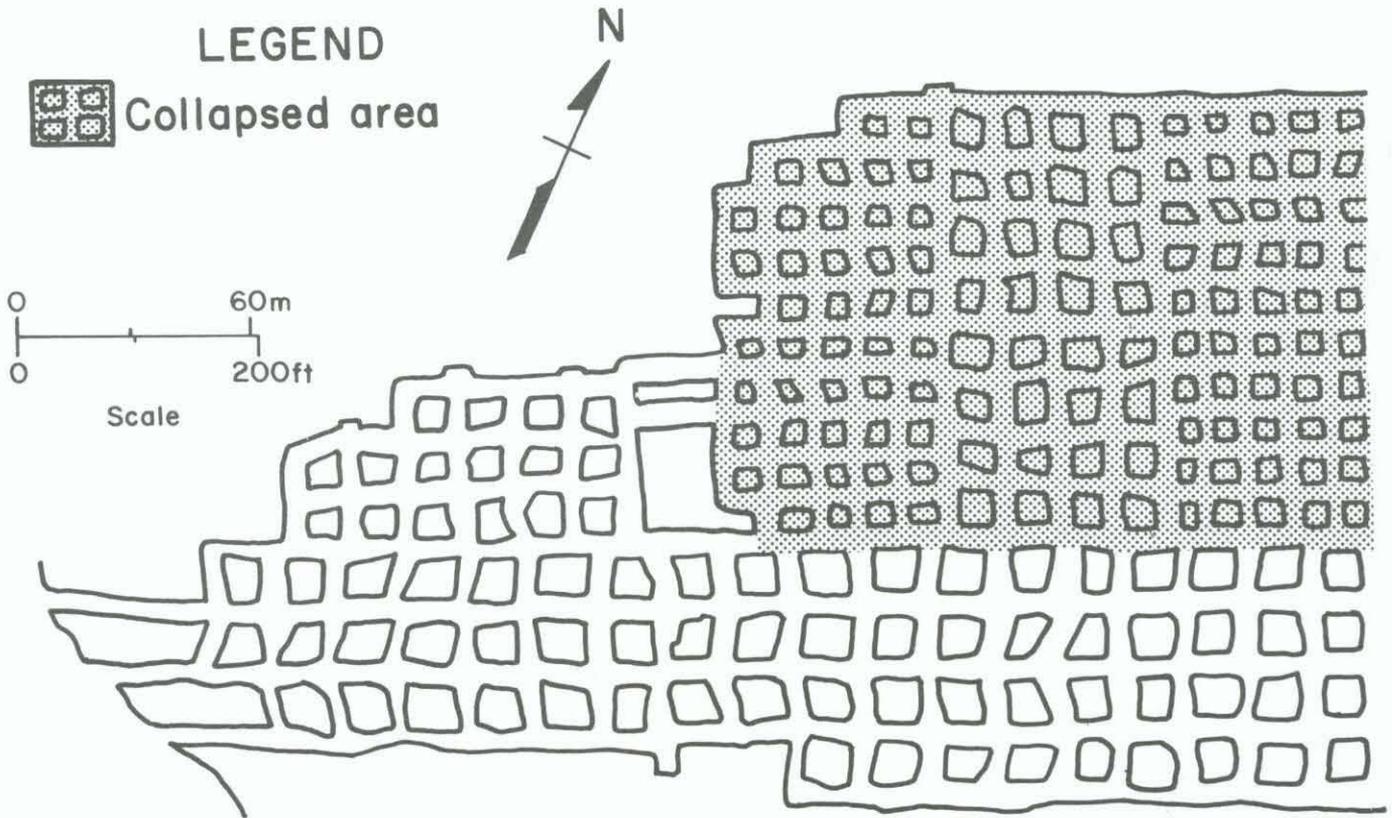
Figure 7. Failed development pillars in Mine D.

SF=1.45 failed. As shown in figure 7, the occurrence happened in a panel driven off the mains. The resultant airblast blew out 37 stoppings. The only other stopping in the mine had a hole in it. Some of these stoppings were as far away as 244 m (800 ft) from the perimeter of the collapse. In one stopping, it was determined that some of its 14 kg (30 lb) cinder blocks had been hurled 152 m (500 ft). Fortunately, the occurrence happened on a idle shift and no one was in the mine. The collapse was halted by pillars in the main entries which were 12 x 12 m (40 x 40 ft) and had a SF=3.38. Cover over the collapsed area was 69 m (225 ft).

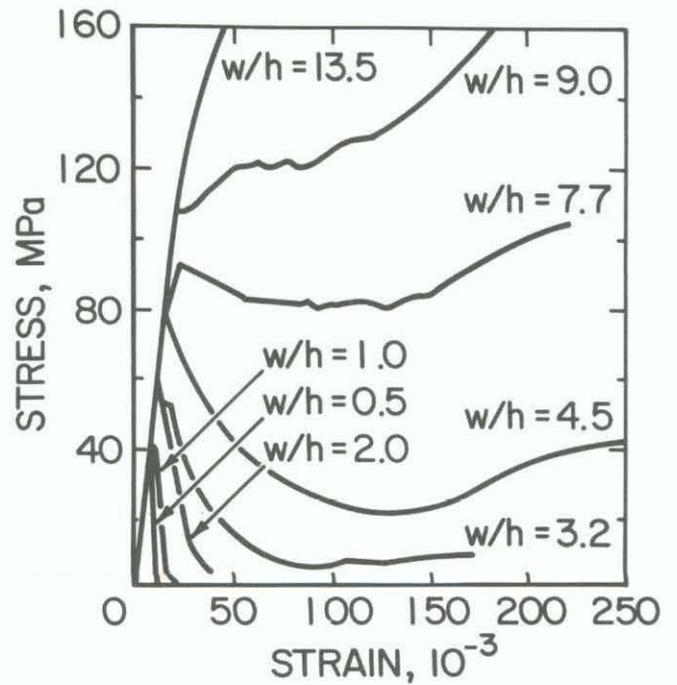
Figure 8 presents complete stress-strain curves for laboratory tests on coal specimens with different width-to-height (w/h) ratios. These curves show the peak strength of the coal specimens and their postfailure modulus. Peak strength is the maximum applied stress on a specimen prior to the initiation of specimen failure. Postfailure modulus is the slope of the downward-curving portion of the complete stress-strain curve after peak strength. Figure 8 shows that peak strength increases as the w/h ratio increases. Furthermore, specimens with a w/h ratio less than three have almost no residual strength, which means that their load-bearing capacity decreases to almost zero after they fail. In addition, specimens with low w/h ratio have a lower (more negative) value for the postfailure modulus. As suggested in figure 8, the postfailure modulus increases and becomes positive beyond a certain w/h ratio.

Figure 8. Complete stress-strain curves for Indian coal specimens, showing increasing residual strength with increasing w/h ratio (Das, 1986).

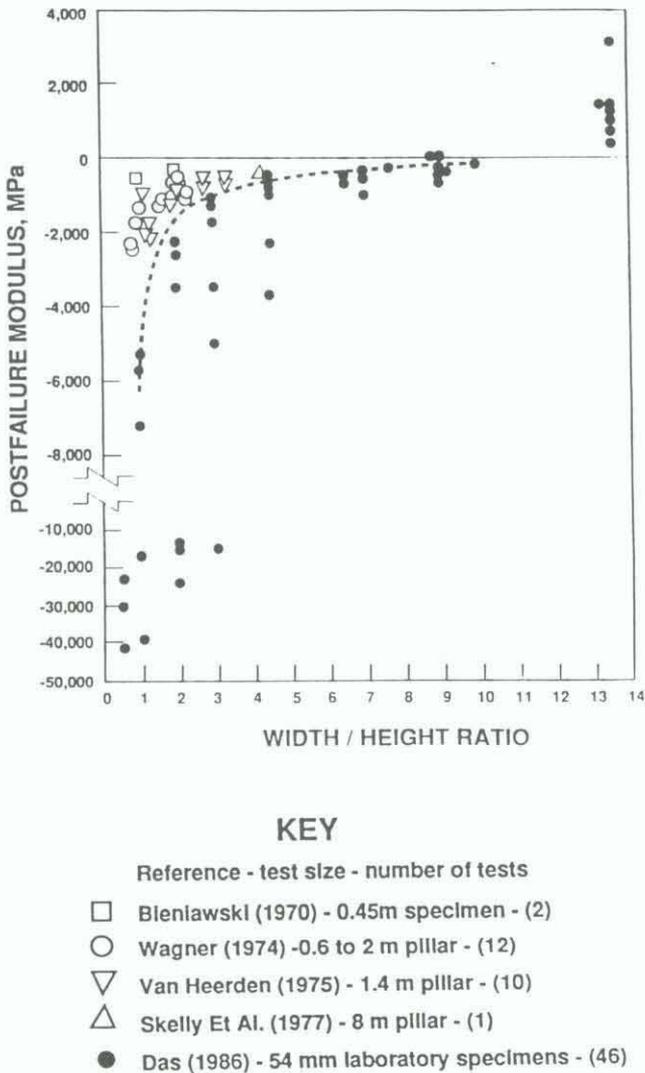
Figure 9 summarizes available postfailure modulus data for large in situ coal specimens and full-scale coal pillars. The dashed line indicates a conservative envelope for this limited in situ data. Also included in this figure are results from recent laboratory tests on Indian coals as reported by Das (1986). In general, the laboratory postfailure moduli exceed the large scale test values in magnitude. The laboratory data also suggests that beyond a w/h ratio of about 10, the postfailure modulus is always greater than zero. Since violent failure should be impossible for such strain-hardening materials, this observation may have important mine design consequences for avoiding catastrophic pillar collapses.

Figure 9. Postfailure modulus of coal pillars, in situ coal specimens, and laboratory samples.

unstable case, the K_p of the coal fenders with w/h ratio of 1.05 was assumed to be -9,000 MPa (-1,300,000 psi) which is slightly high according to the postfailure modulus data shown in figure 9. A different rock mass value of 5,500 MPa (800,000 psi) is also assumed, which means that the K_{LMS} approaches -5,500 MPa (-800,000 psi). Therefore, as shown in figure 12, this case violates the mine stability criterion since K_{LMS} is greater than K_p . The BEM model should produce an unstable failure.

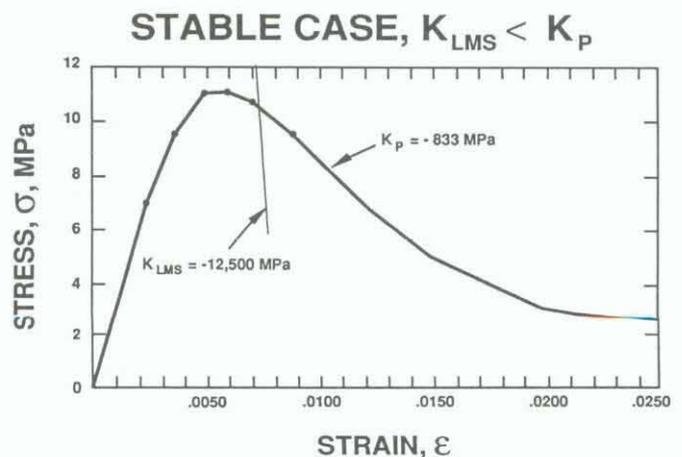
Figure 10. Pillar characteristics and Local Mine Stiffness used in the stable case BEM analysis.

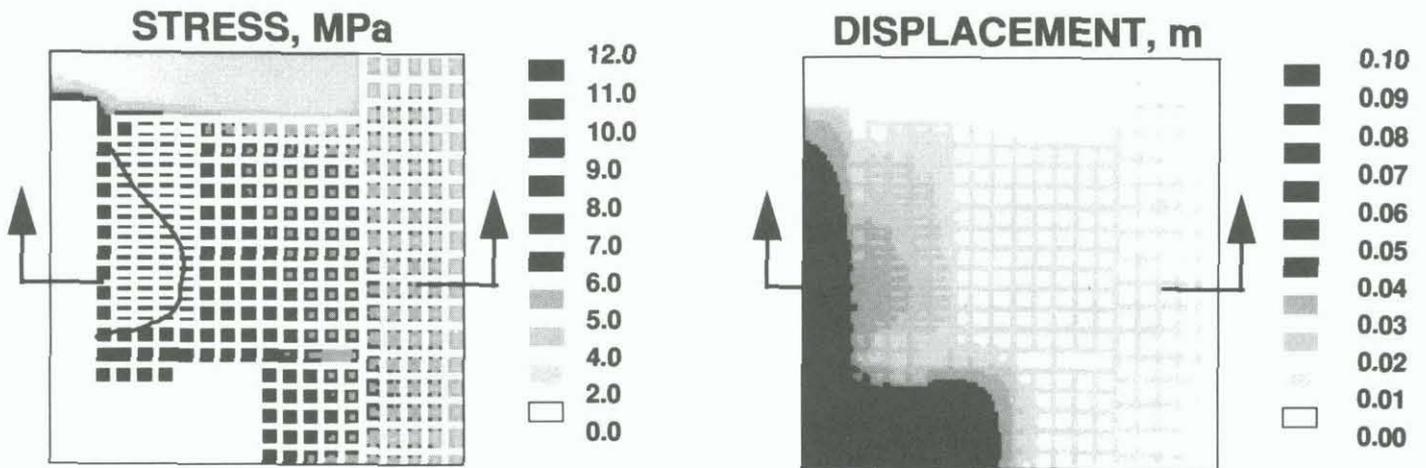
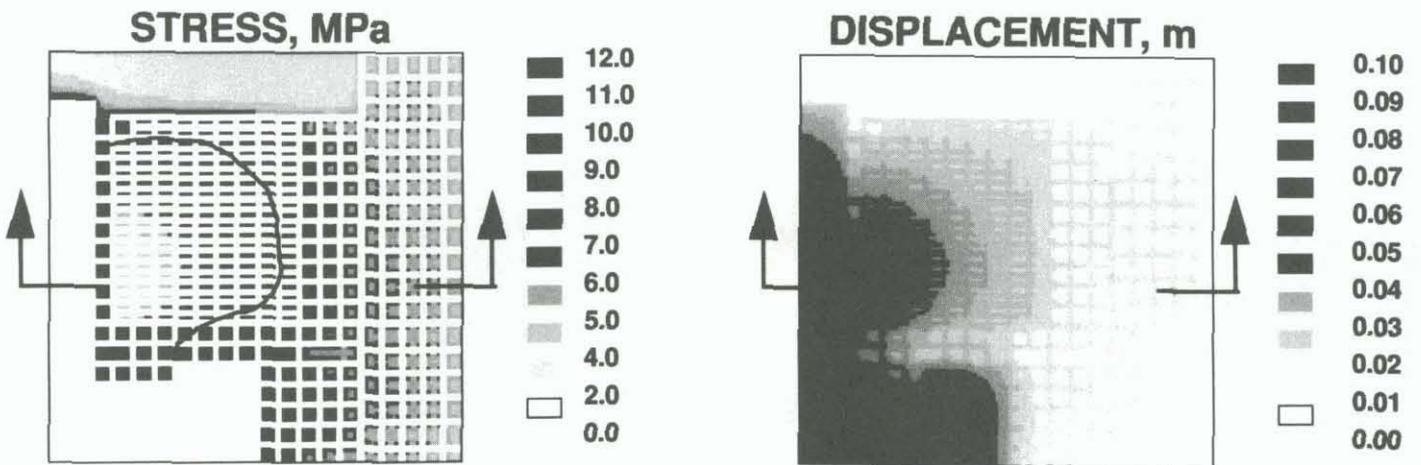
Figure 11. BEM results for the stable case.

Figure 11 shows calculated stresses and displacements after mining 4 and 9 rows of pillars, respectively. Pillars to the right of the peak stress line have not failed, while those to the left are in the process of failing. In other words, pillars to the right of the peak stress location line are on the ascending portion of the stress-strain curve shown in figure 10, while those to the left of that line are on the descending portion of the curve. Failure progresses gradually, and the stresses within pillars gradually decrease to the residual

Failure progress after mining 4 rows

Failure progress after mining 9 rows

stress level of 2.5 MPa (360 psi). Also, as shown in figure 11, displacements (convergence) in the panel increases gradually with additional mining. The failure progress follows the extraction progress, with each increment of mining leading to an approximately equal increment of additional failure. This illustrative BEM analysis closely approximates the desired behavior in room-and-pillar retreat mining, and unfortunately did not occur at mine A.

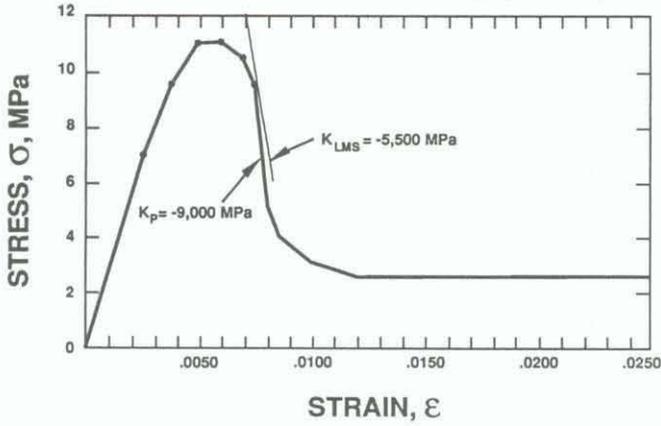
UNSTABLE CASE, $K_{LMS} \geq K_P$

Figure 12. Pillar characteristics and Local Mine Stiffness used in the unstable case BEM analysis.

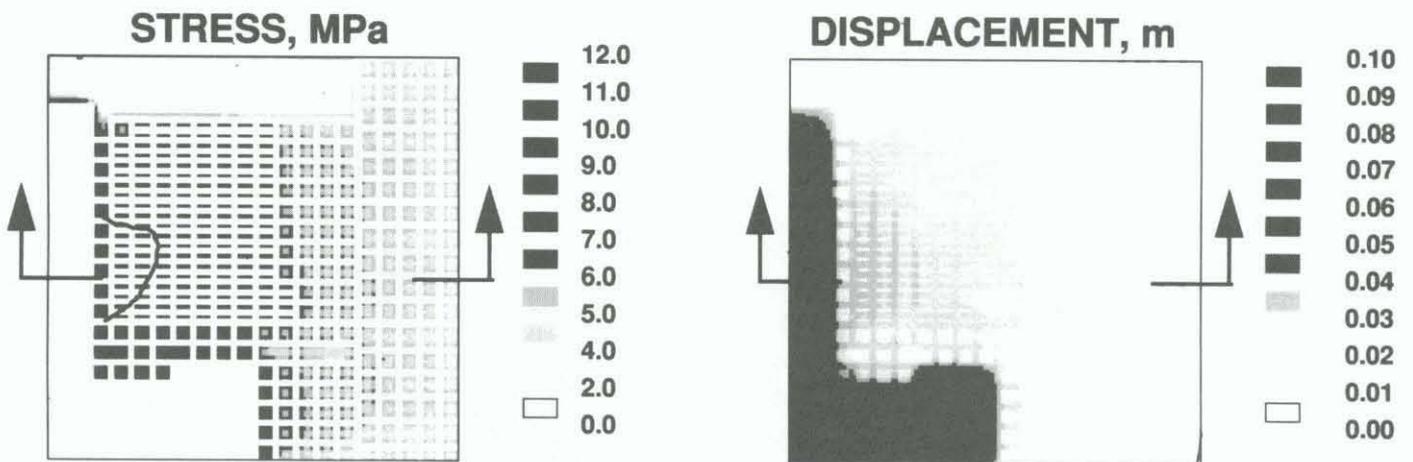
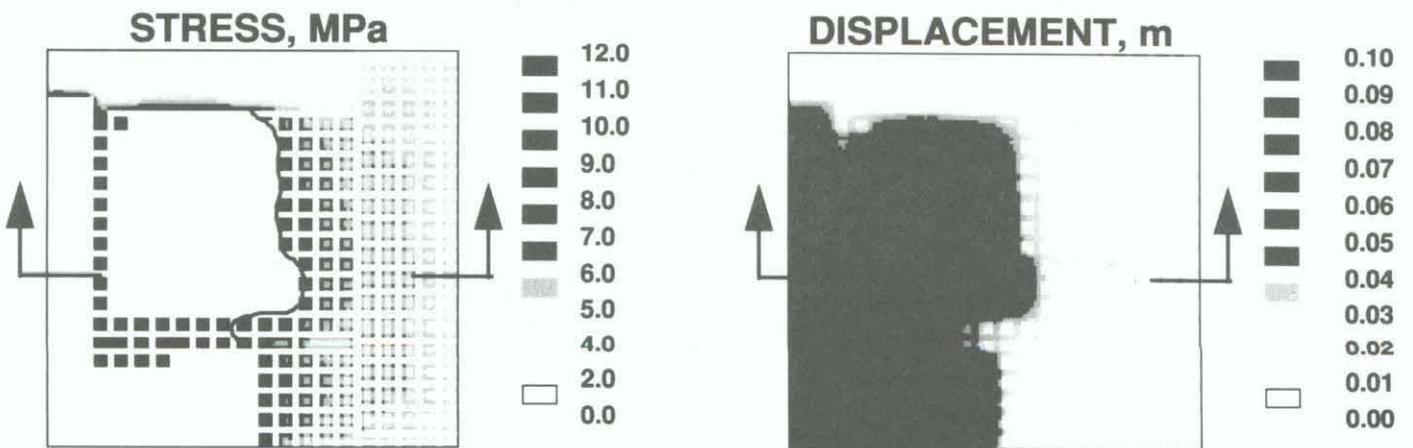
Figure 13. BEM results for the unstable case.

Figure 13 shows calculated stresses and displacements before and after the simulated massive pillar collapse.

Before massive pillar collapse

After massive pillar collapse

Before the failure, pillar splitting has been completed in 8 rows of pillars plus 2 pillars in the 9th row. Close examination of the stresses indicates that most of the fenders are approaching the peak stress of 11 MPa (1,600 psi). Again, pillars to the right of the peak stress location line are on the ascending portion of the stress-strain curve shown in figure 12, while those to the left of that line are on the descending portion of the curve. Splitting just one more pillar in the 9th row triggers disaster. An unstable "chain reaction" develops. As one pillar fails, it transfers load to adjacent pillars which in turn causes them to fail. Stress levels in the failed pillars decrease immediately to the residual stress level of 2.5 MPa (360 psi), as prescribed by the unstable stress-strain curve. The remaining stresses transfer to the fringes of the failed panel. Displacement (convergence) in the panel increases dramatically after the failure. Failure does not follow the mining progressively. The BEM analysis shows that a small increment of additional mining leads to a much larger increment of additional failure.
