# 18th INTERNATIONAL CONFERENCE ON

**GROUND CONTROL IN MINING**

August 3 – 5, 1999

# **Proceedings – 18<sup>th</sup> International Conference on Ground Control in Mining**

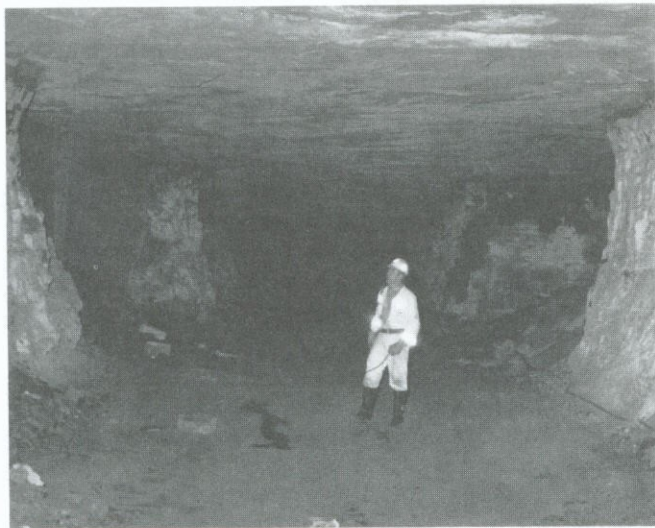
Figure 5 The workings in the area where the pillars did not collapse was about 4 m high.

The pillar collapse area was easily discernable: the pillar conditions changed from undamaged to totally crushed out in the space of three lines of pillars, a distance of about 50 m. In the undamaged area, the free height was about 4 m and in the crushed area, less than 2 m. This is shown in Figures 5 and 6.

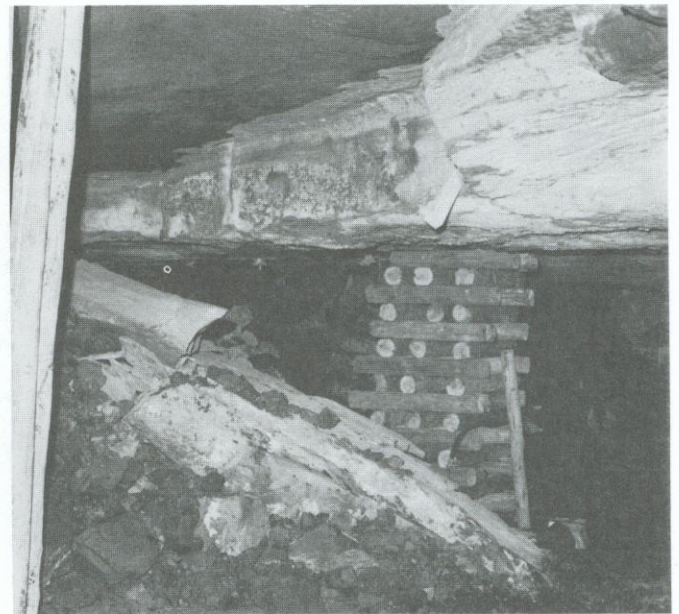
Figure 7 In general the roof was in good condition, although some falls of 0,5 to 1 m had occurred.

The pillar sides were covered in finely broken coal of about 10 to 20 cm diameter. The angle of repose of the broken material was about  $45^\circ$ . In the areas where no loading out for access was done, the free height was about 1,0 to 1,5 m and the span at roof height was in the range of 2 to 3 m. In general, the roof was in fair condition with isolated falls of approximately 50 cm to 1 m high. This is shown in Figure 7.

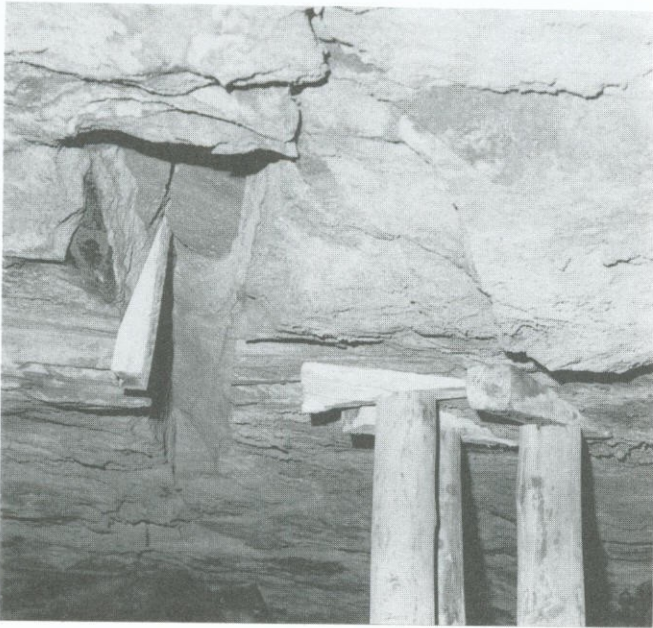
Figure 8 Warning wedges placed into the cracks.

On closer inspection, the roof was seen to be severely cracked with fresh fractures about 1 cm or more wide. These wide fractures were spaced at about 2 to 3 m with finer cracks in between. An example is illustrated in Figure 8.

- Only persons involved in the extraction process were to be allowed in the area.
- Minimum number of people to be involved.
- Guards to be placed at the last unfailed pillar line.
- Warning wedges to be inserted in the roof cracks.
- Stooping convergence warning devices to be used.
- Minimum coal to be removed for passage.
- Mine poles and timber packs to be installed.
- "He-man" to be operated remotely.
- Nobody to be within 20 m of the "He-man" when in operation.
- People in the extraction area to spread out linearly.
- Additional regular checks on gas sensing instruments to be done.

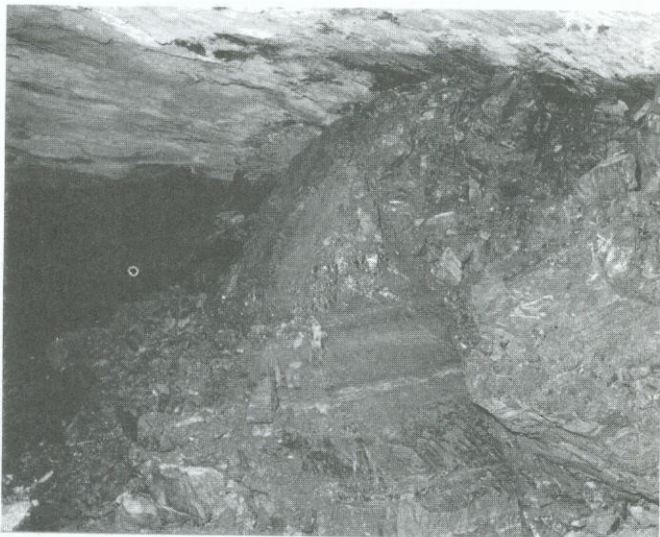
Figure 9 Illustration of the larger blocks into which the inner portions of the pillars had failed and the wavy nature of the roof.

Once the finely broken rubble against the pillar sides was removed, the interior coal was seen to be broken into larger blocks, measuring 50 to 100 cm. The roof contact was distinct and apparently cohesionless, but can be described as rough, with an estimated coefficient of friction about 1,2 to 1,5. The sandstone roof was wavy with wave amplitudes of about 10 cm

and wavelength of approximately 1 m. This is shown in Figure 9.

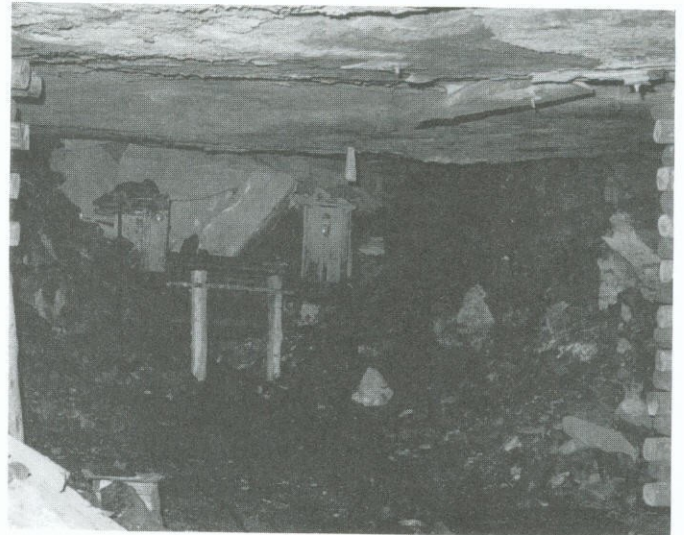
Figure 10 The shuttle car that was trapped by a roof fall, blocking the road to the other equipment.

One shuttle car - shown in Figure 10 - was trapped by a roof fall. The other one was free, but behind the trapped one. The roofbolter was in good condition but also behind the trapped car. The switchgear was severely damaged and the loading chute likewise not considered worth rescuing. The two shuttle cars and the roofbolter were the items to be extracted. The first operation would be the most difficult one. If the shuttle car could be removed, it would be easier to reclaim the other equipment.

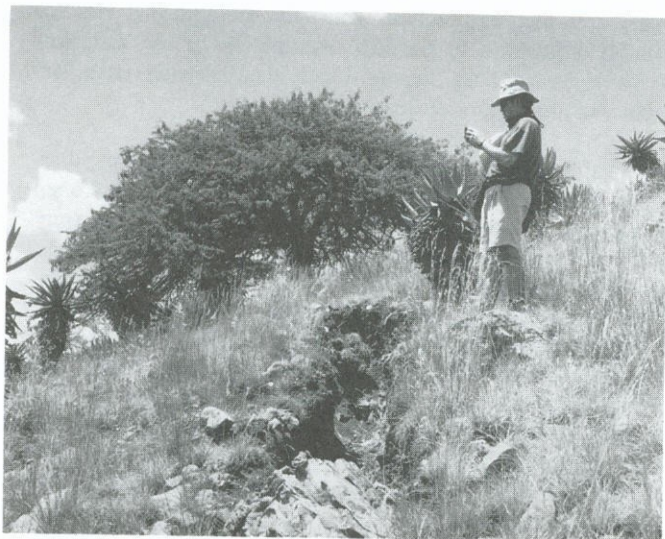
Figure 13 Part of the fresh crack that was found, associated with the Alfred seam collapse.

A variety of older and very fresh cracks were found, as shown in the examples in Figures 12 and 13. The cracks were superimposed on the Alfred seam plan, shown in Figure 14. From this, the following were deduced:

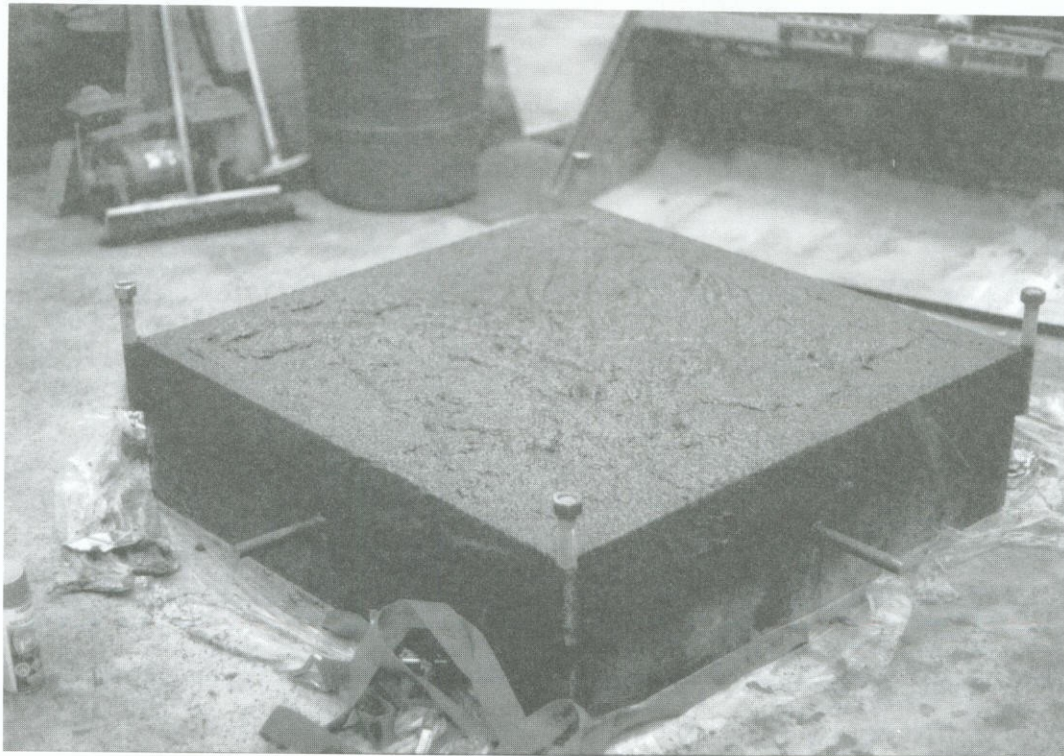
Figure 3. Box frame after loading with loose rock and spray coating with Tekflex.

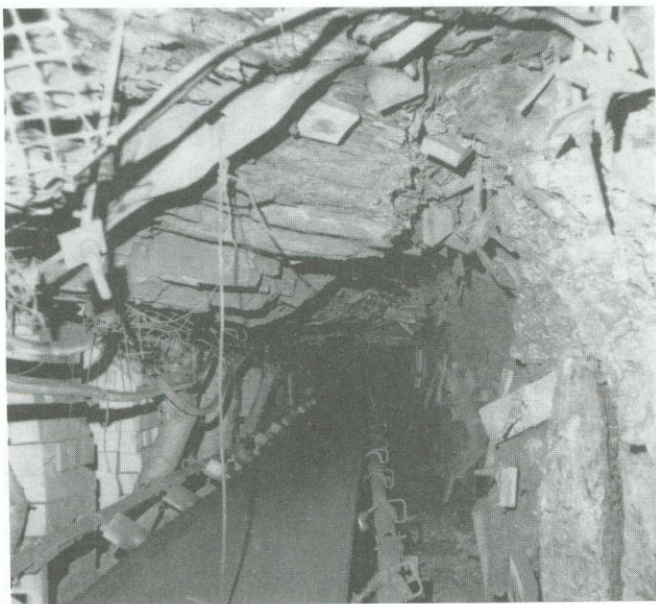
Figure 4. Cutter Roof Along Low Side Rib.

The Sydney Coalfield has long experienced the effects of high horizontal stress (Payne, 1998). The direction of principal horizontal stress is observed to be  $N60^{\circ}E$ . The 8 East Maingate was driven at  $S87^{\circ}E$ , therefore the angle to the principal horizontal stress is  $33^{\circ}$ . A cutter often develops along the low side of the roadways, depending on immediate roof geology (Figure 4). The principal horizontal stress subsequently becomes elevated at the maingate end during longwall retreat as this corner leads into the horizontal stress field.
